## Failure To Transfer Sensor Components Results In Shaft Seal Failure Or Check Engine Light

1992-2004 Mazda and Mitsubishi vehicles with sensor-equipped power steering pumps.

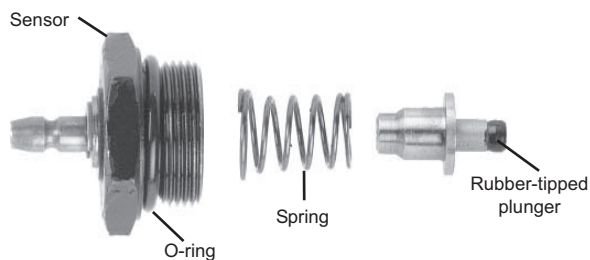
**Figure 1. Pressure Sensor Assembly (Rubber-tipped plunger)**

It may be necessary to transfer the original sensor and its components (shown below) to the replacement pump. If these components are not transferred correctly, shaft seal failure results due to excessive pressure, or if the sensor is defective, code P550 is set.

Figure 1 shows the sensor, spring and rubber-tipped style plunger. Be sure components are installed in the order shown, and the rubber-tipped plunger is installed in the direction shown. Note that the metal-tipped style plunger shown in Figure 2 may be installed in either direction if the metal plunger separates from the brass holder. The third style, Figure 3, is already assembled as one piece. Be sure to thoroughly clean the sensor and its components, and install the sensor using the new supplied O-ring. Refer to the vehicle service manual for correct tightening specs. Replace a damaged or defective sensor (dealer item). If code P550 is set, be sure to verify proper operation of sensor and the ECM before servicing or replacing the power steering pump.
