CARDONE™ ProTech®

Chrysler Drivetrain Alignment Prevents CV Pop-Out

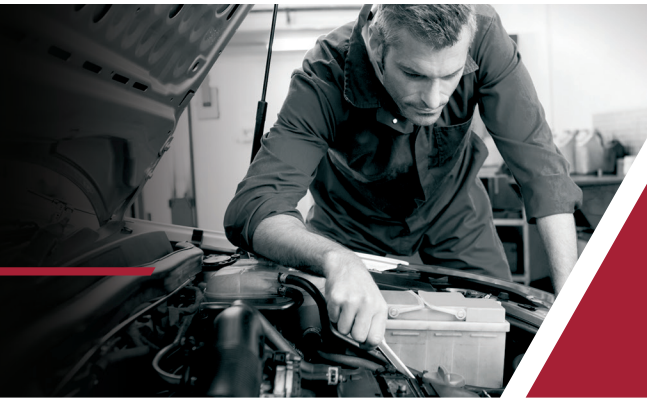
Vibration, inner joint pulling out of the transaxle or catastrophic axle failure, leaving the vehicle dead in its tracks (especially Chrysler products).

Drivetrain alignment out of specifications caused by:

- Defective or maladjusted engine mounts
- Missing or loose mounting hardware
- Front end damage

Equal length axles: With the vehicle on the ground, measure the distance from the small boot clamp on the outer joint to the large boot clamp on the inner joint. If unequal, loosen the engine/trans mount bolts and adjust the drivetrain until both measurements are equal.

Different length axles: Remove the nuts from both axles. Push axle towards the transmission and bottom out the inner joint. Measure the distance the stub shaft has moved into the hub. Repeat for the other shaft and compare the measurements. If unequal, loosen the engine/trans mount bolts and adjust the drivetrain until both measurements are equal.
