CARDONE ProTech

Mis-Diagnosed Power Steering Pump Noise

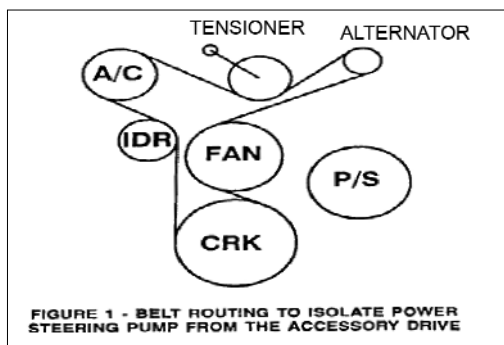
A whine noise emanating at the front of the vehicle that appears to be coming from the power steering pump.

The noise may actually be the result of a failed bearing in the alternator.

1. Isolate the power steering pump from the alternator by installing an accessory drive belt off of a 3.4L equipped 1993 or 1994 Camaro or Firebird. Install the diagnosis belt as shown in FIGURE 1.
2. Run the engine and listen for the noise. Do not drive the vehicle with this belt attached. If the noise is gone, the power steering system is most likely at fault. If the noise remains, proceed to diagnose the remaining elements of the accessory drive including the generator.
3. After the noise is successfully corrected, remove the accessory drive belt used for diagnosis.
4. Install the original accessory drive belt as shown in FIGURE 2.
