CARDONE ProTech

Clogged Power Steering Reservoir Filter - Toyota & Lexus

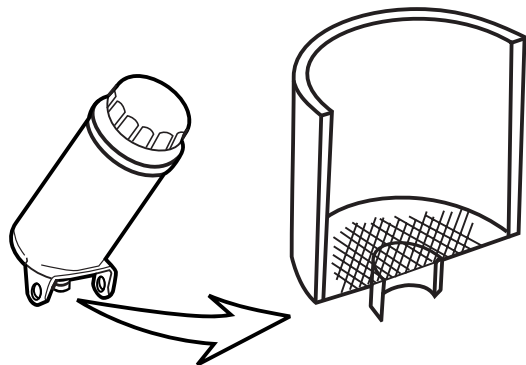
Noise or reduced assist may be caused by restriction in the power steering fluid reservoir. Most Toyota/Lexus-style reservoirs have a filter screen at the bottom. Over a period of time this filter could get clogged causing the restriction of fluid.

Cut-away of a typical reservoir showing internal filter screen

Replace any hose that shows signs of cracking or internal deterioration. Thoroughly flush the power steering system; then remove the reservoir for cleaning as follows:

1. Clean the exterior and interior of reservoir with new power steering fluid or suitable solvent.
2. Blow off the filter screen using pressurized air until restriction or clog is removed.
3. Using a flashlight, check to make sure that the filter screen is free of debris. **Note:** Contamination may be an indication of internal breakdown of hoses, which must be replaced before operating the vehicle. Failure to replace bad hoses could damage both the pump and steering unit.
4. Reinstall reservoir, referring to the service manual for tightening specs and bleeding procedures.
