81-158PB Replacement Pulse Board Park Problem

SCA3211 PT 40-0005

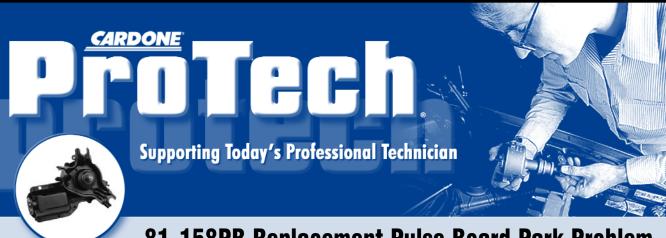
Problem: Wipers will not park after replacing Pulse Board.

Cause: Contact arms on Pulse Board may not be contacting Wiper Motor. Packing material or movement during shipping may have bent contacts.

Check position of contact arms before installation. Contacts should be approximately 1 inch (25 mm) above circuit board (see picture). Correct contact position ensures proper Wiper Motor parking function.
