TECHNICAL SERVICE BULLETIN

TIMING SYSTEM TENSIONING ISSUES CHEVROLET AVEO

BULLETIN TSB_037_US

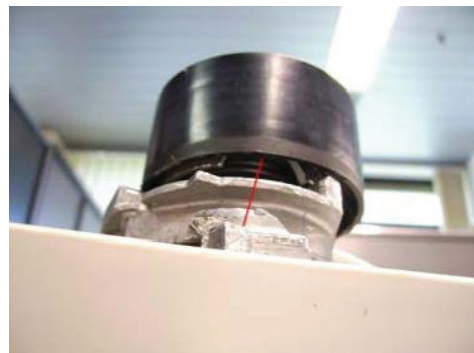
Gates engineers have identified a common issue during the setup of the timing system on these vehicles. Upon a closer look at the failure analysis, we have learned that drive failure is caused by not rotating the eccentric water pump to set proper tension, or setting tension while the engine is hot. Improper tensioning procedures result in a synchronous belt system that will not operate correctly, while drastically diminishing the life of the components. Use of a specific 41mm tool is required to turn the eccentric water pump.

Failure to follow the proper installation instructions can cause failures in the drive system. In this picture you can see the broken off pointer due to tensioner hitting the stops from improper tension, resulting in drive system failure.

*Gates recommends the TCKWP335 Timing Component Kit with Water Pump for this installation due to loosening of the water pump and possibly disturbing the seal.

*On this drive it is important to remember that install procedure should be done with engine at ambient temperature. Failure to do so will cause improper tension in drive system.
