# TECHNICAL SERVICE BULLETIN

## SYNCHRONOUS BELT DRIVE SYSTEM

### REAR CAM ALIGNMENT

BULLETIN TSB\_044\_US

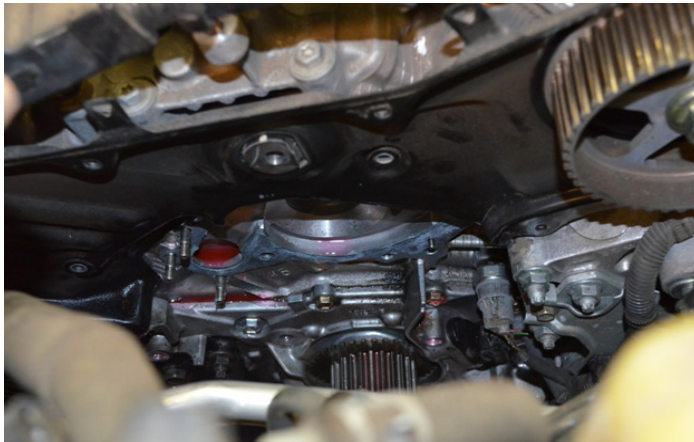
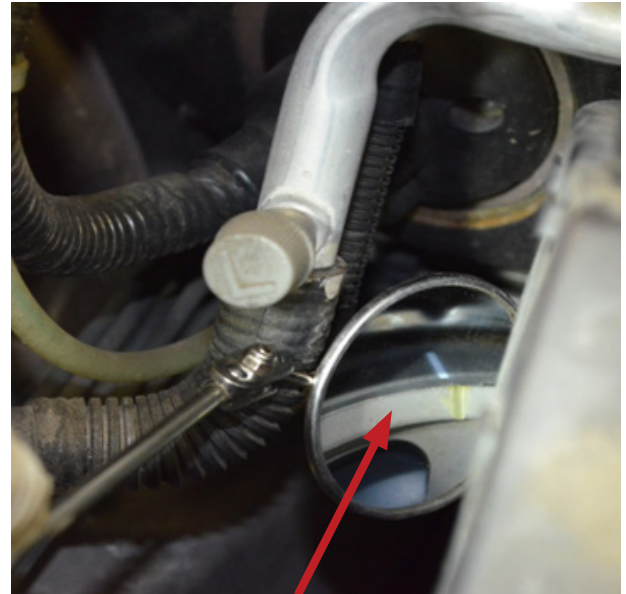
The most common cause found with immediate illumination of the MIL associated to cam sensor codes has been misalignment between the rear cam gear and timing belt. Illumination of the MIL will occur with the cam being one tooth advanced or retarded.

**REAR CAM ALIGNMENT WITH MIRROR FOR VERIFICATION HIGHLY RECOMMENDED**

NOTE: Do not interchange or mix cam gear if they are removed – ensure they are kept in appropriate order. (right vs. left and front vs. rear)

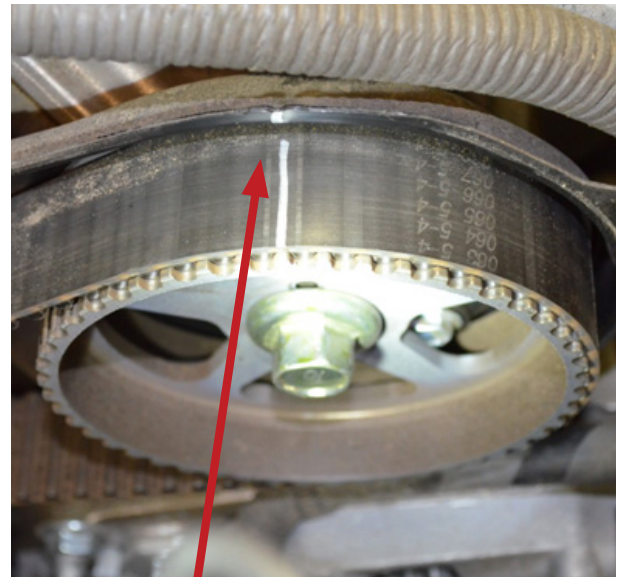
Cautions on related system components would include verification of the upper idler pulley operation. Due to the step design within the pulley, it is possible to secure this component at an improper angle. Ensure the idler pulley is operating within the same system plane and that the timing belt is tracking in the center of the bearing.
