Technical Service Bulletin

AUTOMOTIVE <> PASSENGER CAR SYNCHRONOUS BELT DRIVE SYSTEM

BULLETIN PA008-11

REAR CAM ALIGNMENT

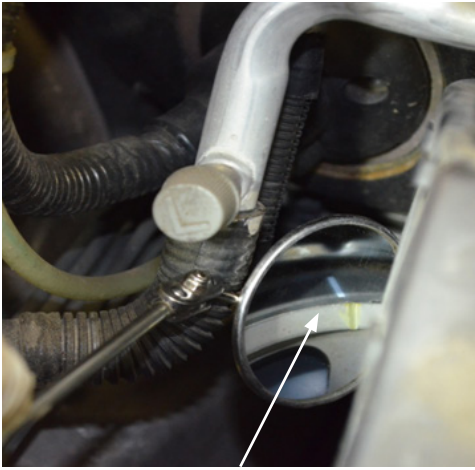
The most common cause found with immediate illumination of the MIL associated to cam sensor codes has been misalignment between the rear cam gear and timing belt. Illumination of the MIL will occur with the cam being one tooth advanced or retarded.

Rear Cam Alignment With Mirror For Verification Highly Recommended

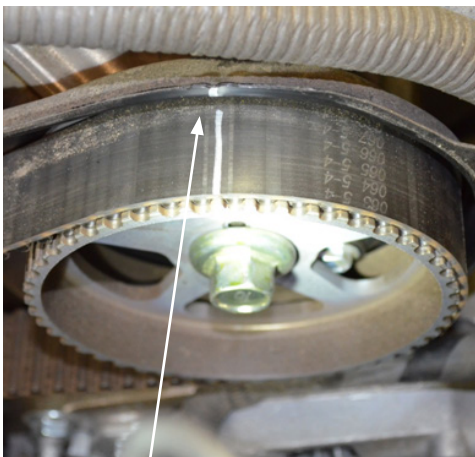
Front Cam Alignment

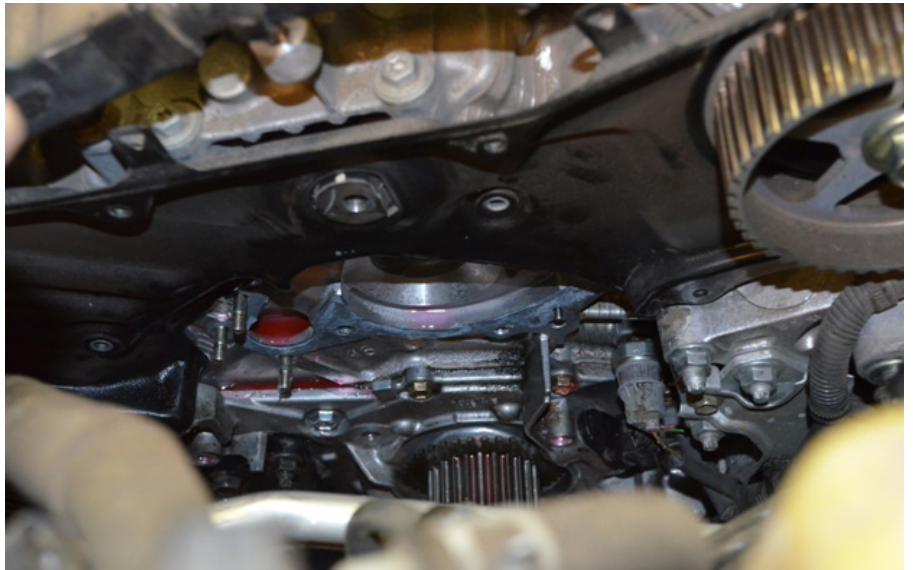
Gates always recommends replacement of the water pump assembly combined with a complete flush of the cooling system when performing timing system maintenance. Removal of the upper rear cam gear cover is unnecessary in order to R&R the water pump unless cam seal renewal is also being performed.

NOTE: Do not interchange or mix cam gear if they are removed – ensure they are kept in appropriate order. [right vs. left and front vs. rear]

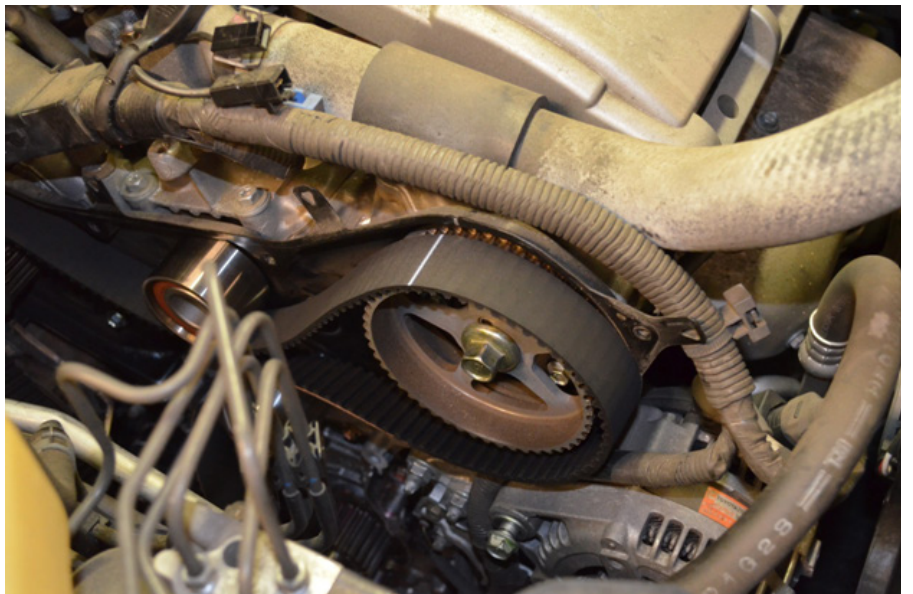
Cautions on related system components would include verification of the upper idler pulley operation. Due to the step design within the pulley, it is possible to secure this component at an improper angle. Ensure the idler pulley is operating within the same system plane and that the timing belt is tracking in the center of the bearing.
