# PROBLEM SOLVER™ BULLETIN

BULLETIN: 27012

## Ford Control Arm with Ball Joint Ford Tempo, Escort, EXP Mercury Topaz, Lynx

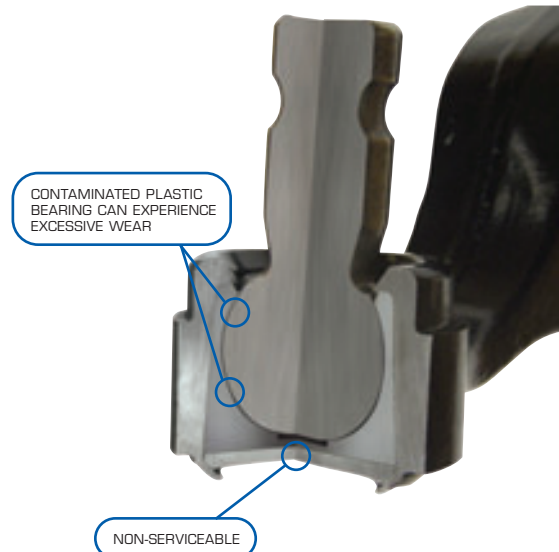
#### Premature Wear

- Ball joints experience premature wear due to intrusion.
- Non-serviceable polymer socket cannot flush contamination, which quickly leads to corrosion and wear, causing excessive deflection in the socket assembly.
- Deflection in the socket assembly causes changes to alignment angles, resulting in steering and tire wear issues.
- Necessary mounting hardware is not included in other replacement part kits, forcing technicians to reuse old hardware.
