PROBLEM SOLVER™ BULLETIN

Premature Ball Joint Wear

1999-2006 GM Trucks

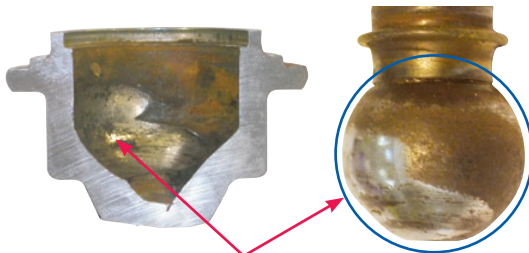
Lower ball joint experiences premature wear

- Original equipment stud ball diameter and OE-style polymer bearing do not provide sufficient load-carrying capability, especially in rough service conditions.
- Load stress and intrusion quickly erode the bearing surface.

NOTE: Distressed OE style polymer bearing due to rough service conditions.

OE part measured 0.080" of play due to bearing failure. As a result, the non-hardened housing and ball stud components wear into each other.

MOOG® K6693 Lower Ball Joint

- The MOOG K6693 lower ball joint was designed with an oversized stud ball diameter that maximizes ball-to-bearing contact.
- Two powdered-metal “gusher” bearings with grease grooves provide the most durable wear surface available.
- The combination of two powdered-metal bearings and an oversized stud ball diameter provides superior load-carrying capability, increased durability and extended service life.
