# PROBLEM *Solver*<sup>™</sup> BULLETIN

## Tie Rod End Failures

2001-2004  
General Motors  
1500/2500/3500 Trucks

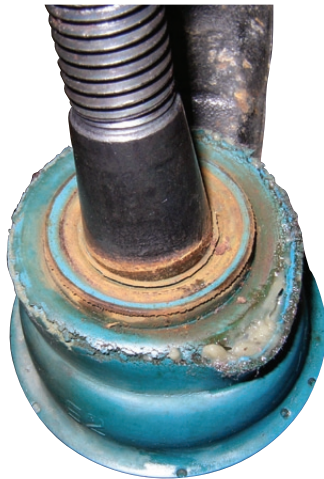
#### OE tie rod ends failing prematurely due to boot failure

- The boot fails, allowing contaminants and moisture inside. Resulting corrosion and wear cause excessive deflection in the tie rod socket assembly, with loose steering and associated toe angle changes. Tie rods with a non-serviceable polymer socket design are unable to flush the contamination, and corrosion/accelerated wear quickly sets in.
- Boot failure is due to the reduction of carbon black strengthening filler in the polychloroprene material in order to achieve a blue color. Reducing carbon black content cuts material strength, resulting in boot degradation and failure.

SILVERADO 2500HD 2WD  
17,613 miles  
OE Outer Dust Boot

#### MOOG® ES3609

- The MOOG tie rod, featuring a greaseable design, uses a premium polychloroprene boot with a special grease-relief valve designed to resist intrusion and flush contamination out of the socket, preventing corrosion and premature wear.
- Hardened powdered-metal “gusher” bearings allow lubrication to penetrate the bearing surface, providing the most durable bearing available for longer service life.
- A full-ball stud maintains ball-to-bearing contact for greater load capacity.
