PROBLEM *Solver*[®] BULLETIN

Premature Wear of Upper Ball Joint

Dodge Ram 2500/3500 4WD,
Ram 1500 w/Mega Cab

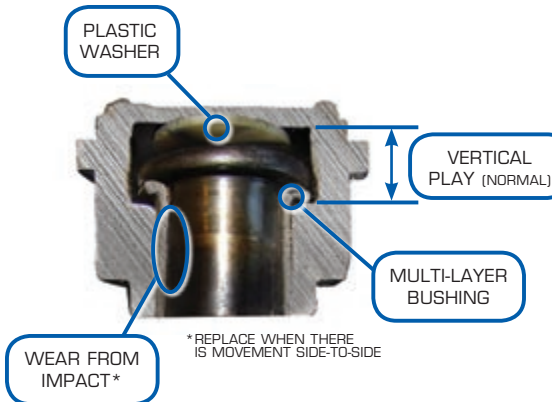
Premature ball joint failures on many late-model Ram trucks are a common occurrence on vehicles equipped with the 9.25" axial.

The installation process puts significant demands on the upper ball joint bowl design. The upper and lower ball joints on these axles may not be perfectly aligned. The OE ball joint design deforms to comply to these demands. This leads to severe wear from impact loads occurring under "normal" driving conditions. The ball joints should be replaced any time there is side-to-side or back-and-forth "radial play" (vertical-only movement is normal).

OE DESIGN IS NON-SERVICEABLE
