Please Review

There have been several factory service bulletins produced by NISSAN to correct charging system problem on MAXIMAS.

617-1TB pg 1 of 3

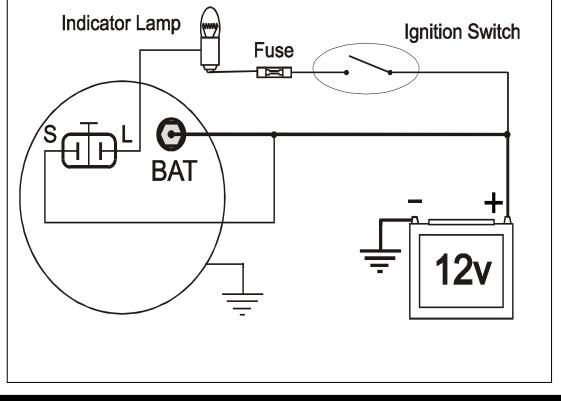
Typical schematic below

Terminal L must receive voltage. This voltage is provided by the indicator lamp on most vehicles.

Failure to have voltage at terminal L may cause:

- No charge, Indicator lamp off.
- Charges OK, but indicator lamp is on.
- Will not charge unless engine is "revved" up.
- Terminal S must have battery voltage. This voltage is supplied directly from the battery and will be present at all times. Failure to have voltage at this terminal will cause:
 - Overcharge or no charge condition, depending on battery design.

The "BAT" terminal must have battery voltage. This voltage is supplied directly from the battery and will be present whether the ignition switch is in the "ON" or "OFF" position. Failure to have voltage at this terminal will cause:

- No charge, indicator lamp on.
- Extremely high voltage at "BAT" terminal.
- Possible damage to alternator diodes.
