TT# 553-1TB

553-1TB(Rev 00) © Publitech, Inc. 1999

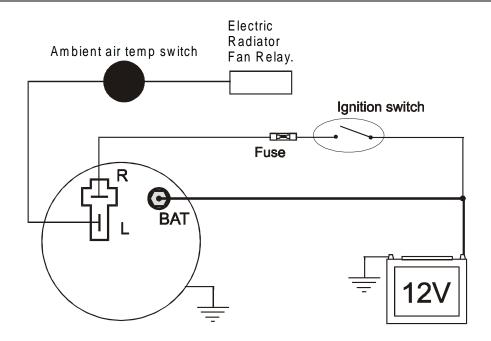
PLEASE NOTE!!! This charging system may have an ambient air temperature switch and electric radiator fan relay. It is possible for either one, or both, of these parts to fail and destroy the alternator. Check these parts whenever the alternator is replaced!!

- 1. The "BAT" terminal must have battery voltage. This voltage is supplied directly from the battery and will be present whether the ignition switch is in the "ON" or "OFF" position. Failure to have voltage at this terminal will cause:
 - Extremely high voltage at "BAT" terminal.
 - Possible damage to alternator diodes.
- 2. In addition, the wire leading to terminal "R" should have voltage when the ignition switch is in the on position. Failure to have voltage at this terminal will cause :
 - No charge condition.
- 3. Most alternator failures are caused by defective/discharged batteries, loose drive belts, or corroded wires. Check for these conditions to prevent a recurring problem!
