## Read This!

**Inspect the old starter solenoid for damage as illustrated below. This type of appearance indicates that internal solenoid damage has occurred due to vehicle problems.**

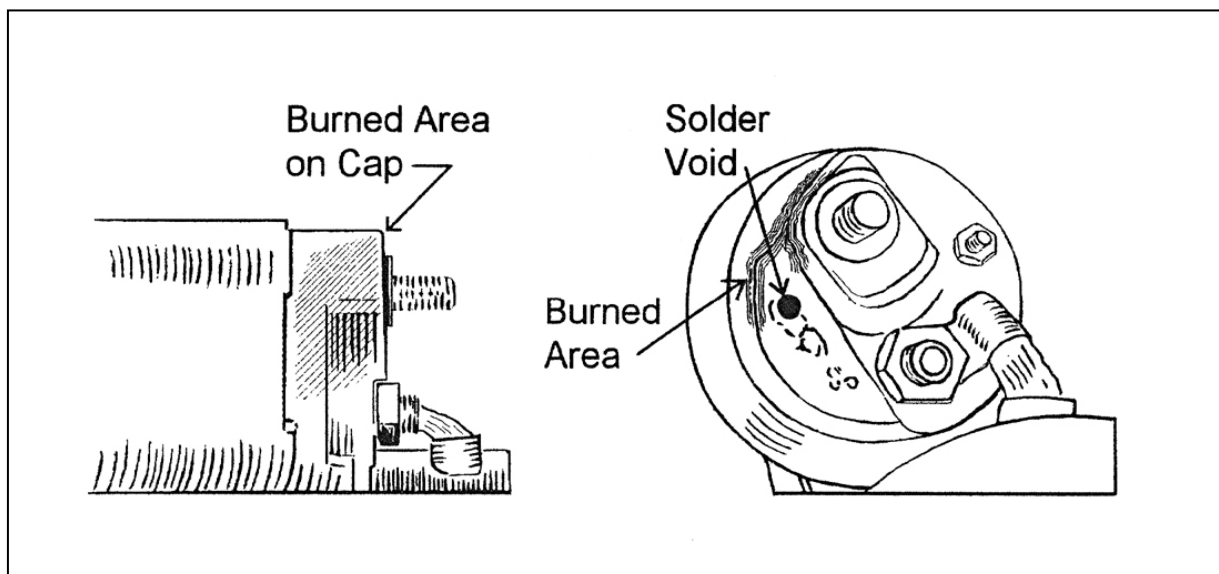
The burned area and melted solder are caused by a defective turbocharger flange gasket. Replace the gasket per OEM recommendations and procedures to prevent reoccurring starter failure.

Shields installed on solenoids assist in diverting heat away - improving starter performance - however repairs to flange gaskets still must be performed.
