Read This!

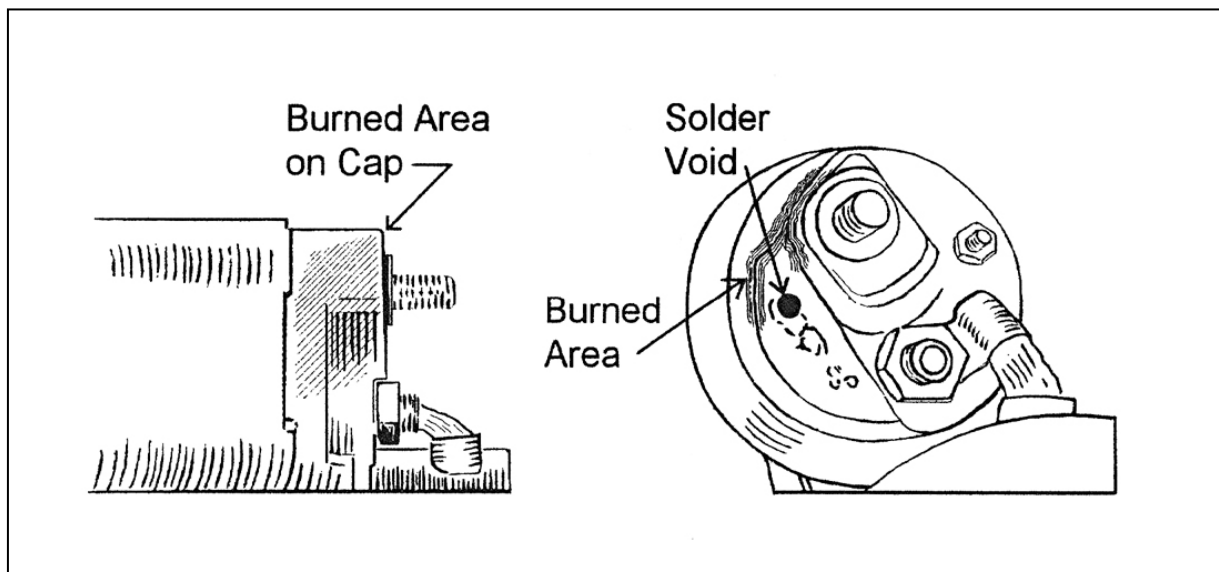
Inspect the old starter solenoid for damage as illustrated below. This type of appearance indicates that internal solenoid damage has occurred due to vehicle problems.

The burned area and melted solder are caused by a defective turbocharger flange gasket. Replace the gasket per OEM recommendations and procedures to prevent reoccurring starter failure.

Shields installed on solenoids assist in diverting heat away - improving starter performance - however repairs to flange gaskets still must be performed.
