TT-201

Cranks over but has a hard start or no start 2003-2004 Ford Excursion, F-Super Duty Equipped with 6.0L and 7.3L Diesel

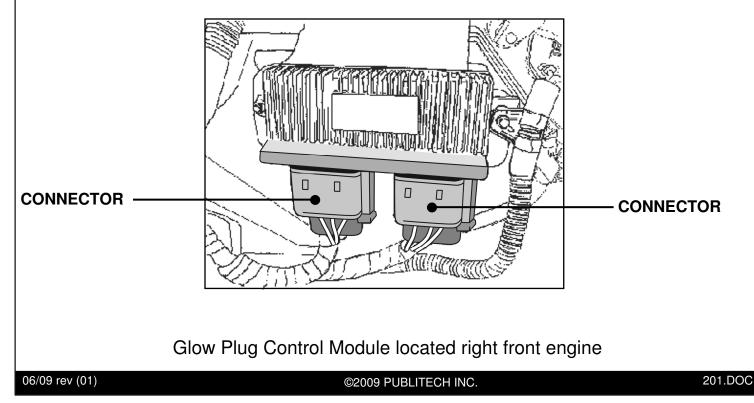
Some vehicles equipped with a 6.0L and 7.3L diesel may have this condition. This may be due to a Glow Plug Control Module **CONNECTOR**. Procedure:

- 1. Make sure battery or batteries are fully charged
- 2. Inspect GPCM connector for:
 - Pin fit. No looseness
 - Pin pulled out
 - Bent pins
 - Corrosion / oxidation
- 3. If connector problems exist, replace connector with service kit from dealer. (GPCM Connector Kit: 4C32-12B568-AA)
- 4. If no connector problems present, proceed with normal diagnosis.
