Repeated Starter Replacement or Poor Cranking Performance

Early VW Applications 6 & 12 Volt systems

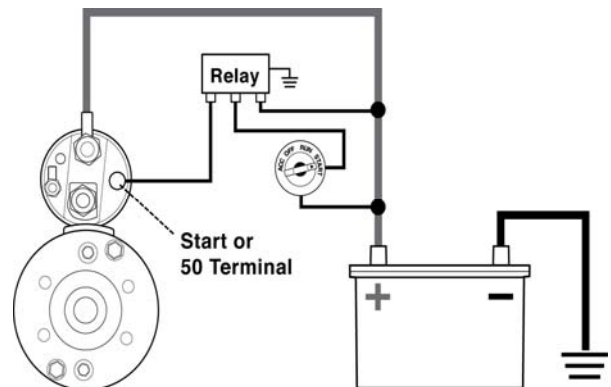
Field reports are indicating various problems with high electrical resistance caused by loose, rusted, corroded, or open connections on the Negative/ Ground paths in the starting system and in the ignition to solenoid wiring, contacts and connections .

2. Review your application for a starter assist relay and replace as needed. Adding a starter assist relay between the ignition switch and starter solenoid (terminal 50) can solve a poor or no start problem in vehicles not previously equipped with one. The relay will by-pass difficult to repair electrical resistance areas and increase voltage to the terminal. Various early model vehicle horn relays are often used. Typical wiring example:
