Alternator Replaced and Still Not Charging?

**DOES YOUR CAR HAVE A
HEATED WINDSHIELD ?**

BATTERY DEAD AGAIN?

1990 LINCOLN TOWN CAR

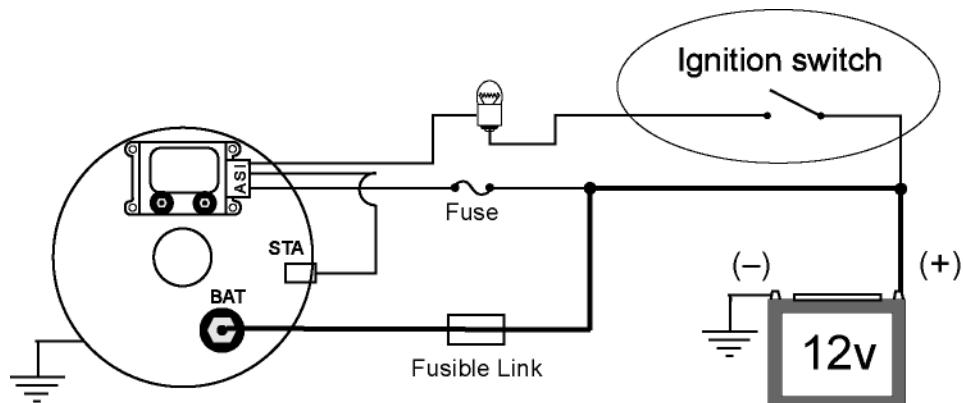
With indicator lamp

- On all systems BAT terminals and "A" terminal must have battery voltage at all times.
- Vehicles with indicator lamps must have at least 10 volts at the "I" terminal.
- Vehicles without indicator lamps must have 12 volts at the "S" terminal.

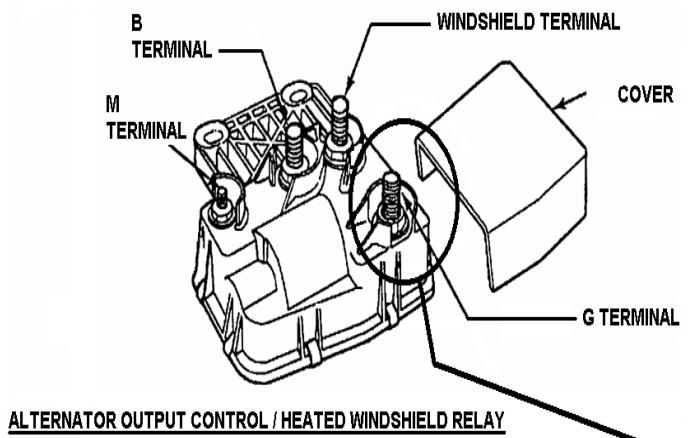
ALTERNATOR OUTPUT CONTROL / HEATED WINDSHIELD RELAY

3. Locate the "Alternator Output Control Relay/Heated Windshield Relay" usually found around passenger side inner fender or near battery. Remove the cover. Remove the 16 gauge wire connected to the "M" terminal and tape it back to the harness.

4. Move the wire/eyelet marked "B" on the relay to the "G" TERMINAL" stud on the relay. Tighten securely. Replace cover.
5. Reconnect (-) negative battery terminal.
