SPECIAL NOTICE
COMET • FALCON 1960-66
MUSTANG 1965-66

IMPROPER INSTALLATION TIE ROD ENDS CAUSE STEERING LINKAGE BIND

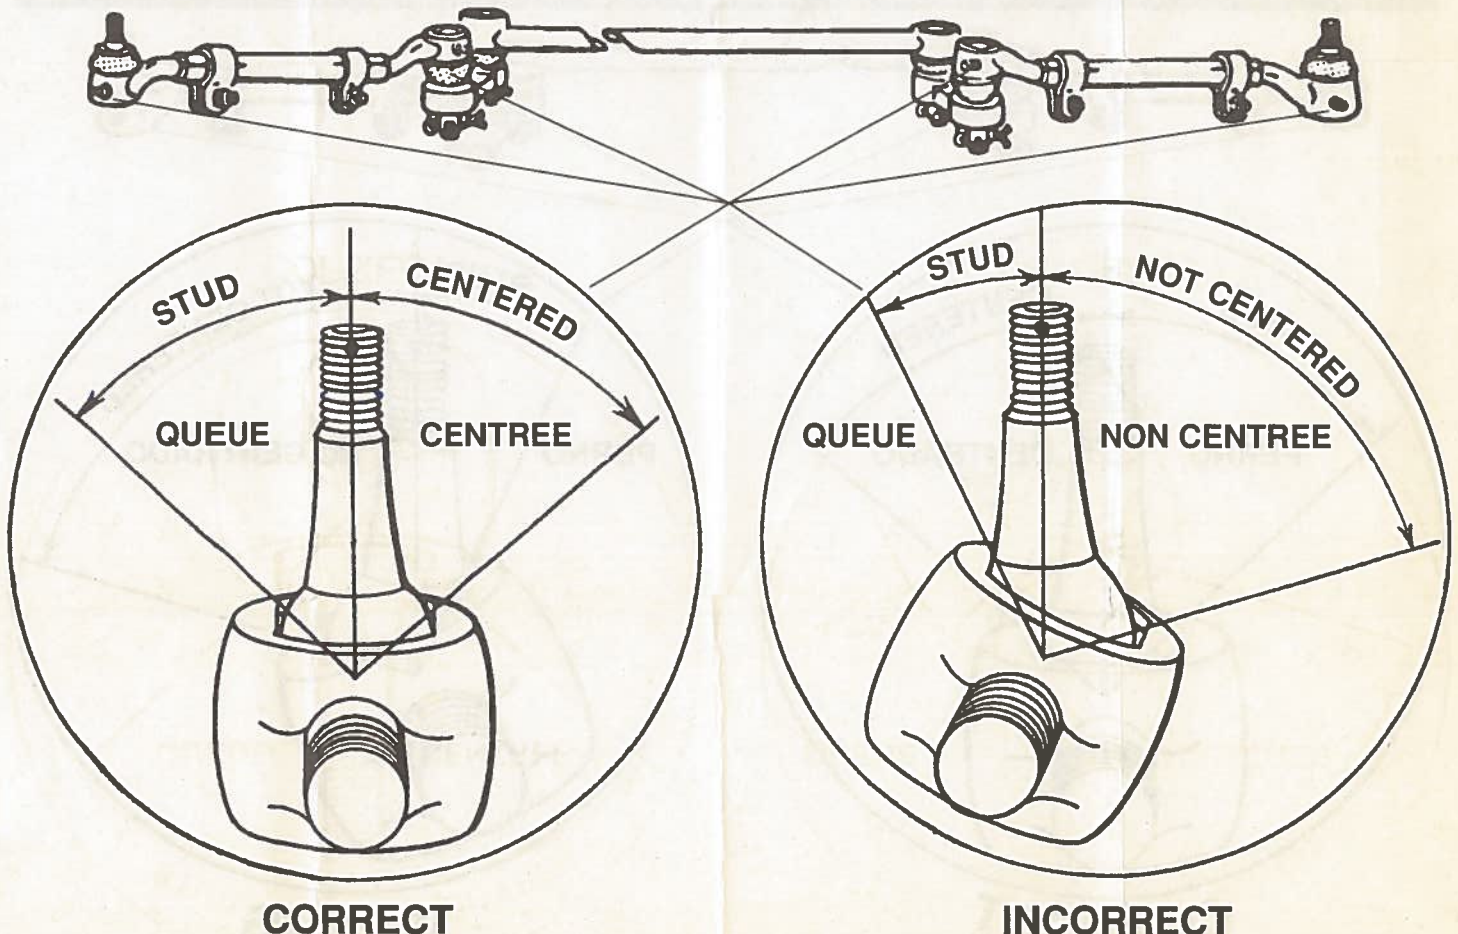
When replacing tie rod ends or performing wheel alignment on MUSTANG, FALCON or COMET cars, special attention should be given to positioning of components. (See illustration). Failure to center tie rod end studs to permit full stud swing can cause binding of the steering linkage resulting in unnecessary wear and in extreme cases failure of the tie rod end.

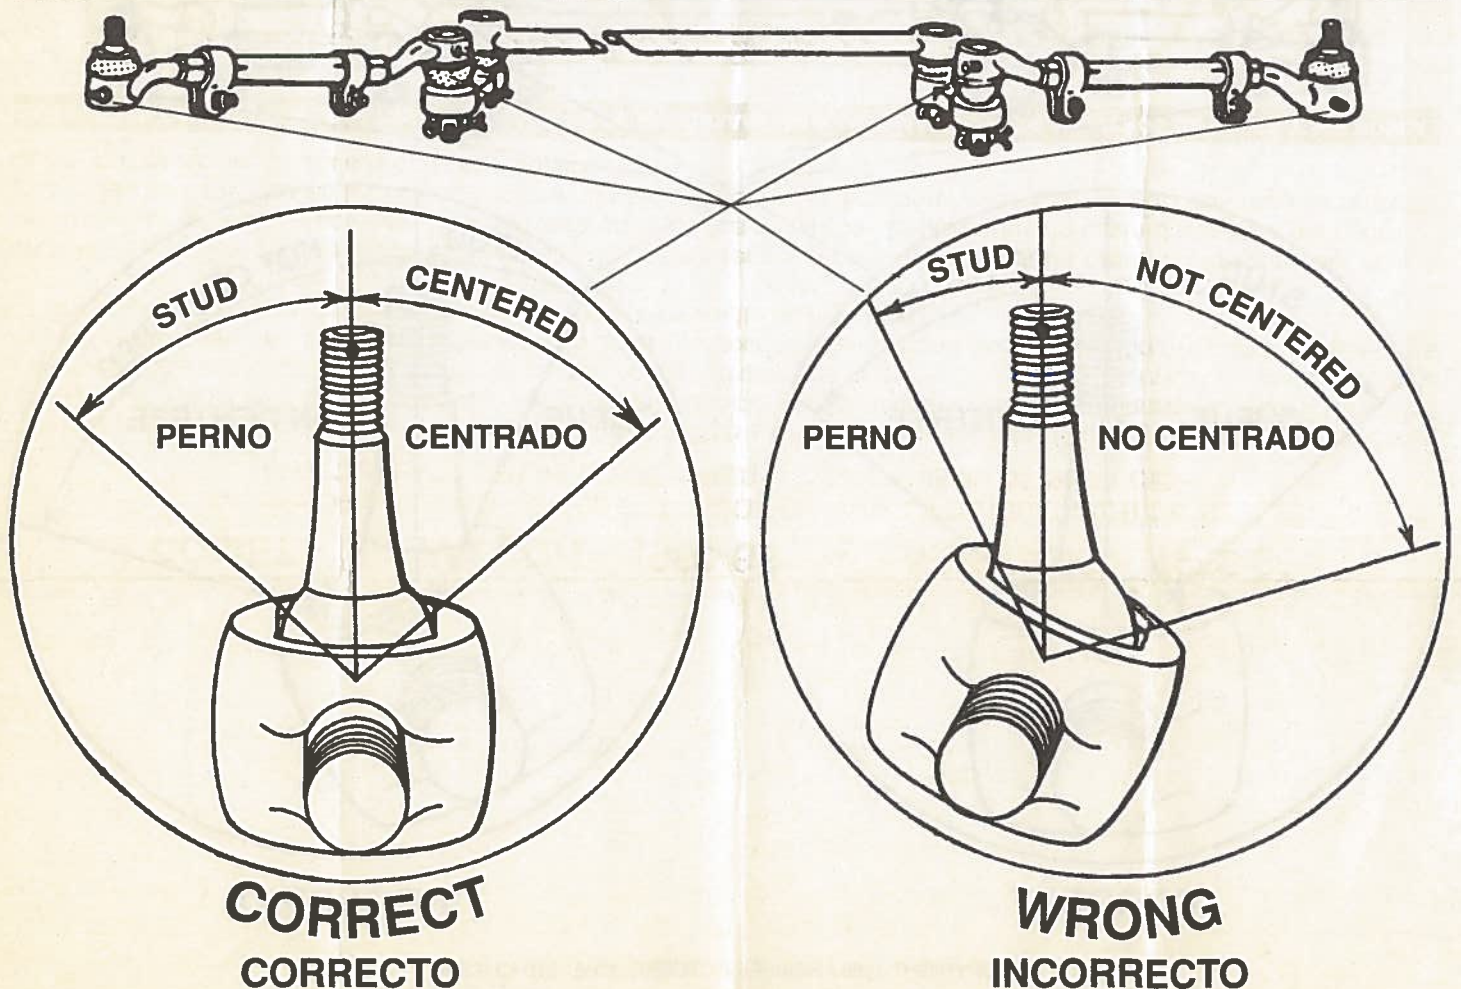
IMPROPER INSTALLATION TIE ROD ENDS CAUSE STEERING LINKAGE BIND

When replacing tie rod ends or performing wheel alignment on MUSTANG, FALCON or COMET cars, special attention should be given to positioning of components. (See illustration). Failure to center tie rod end studs to permit full stud swing can cause binding of the steering linkage resulting in unnecessary wear and in extreme cases failure of the tie rod end.
