## TECHNICAL TIP

536-2TB pg 1 of 3

# This chart is provided to aid you in diagnosing problem areas of the charging system.

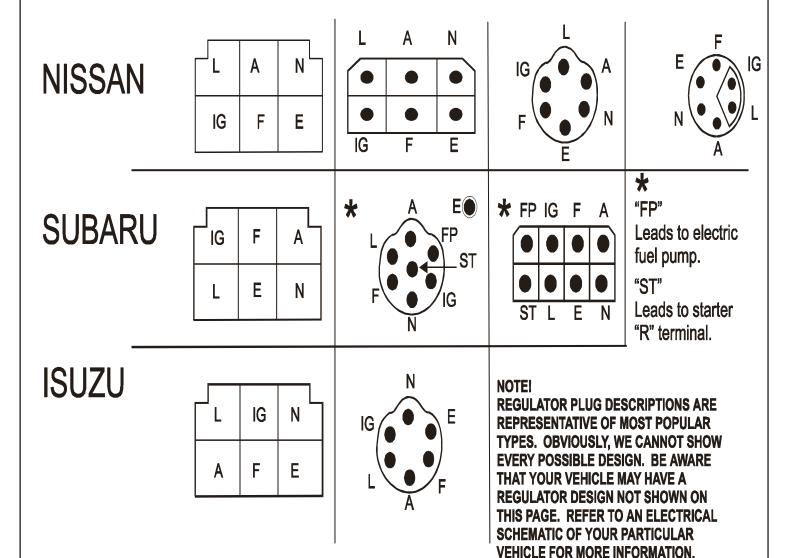
Faulty wiring to the voltage regulator is a frequent cause of charging system complaints.

THE VEHICLE HARNESS CONNECTOR IS SHOWN, FACING THE CONTACTS.

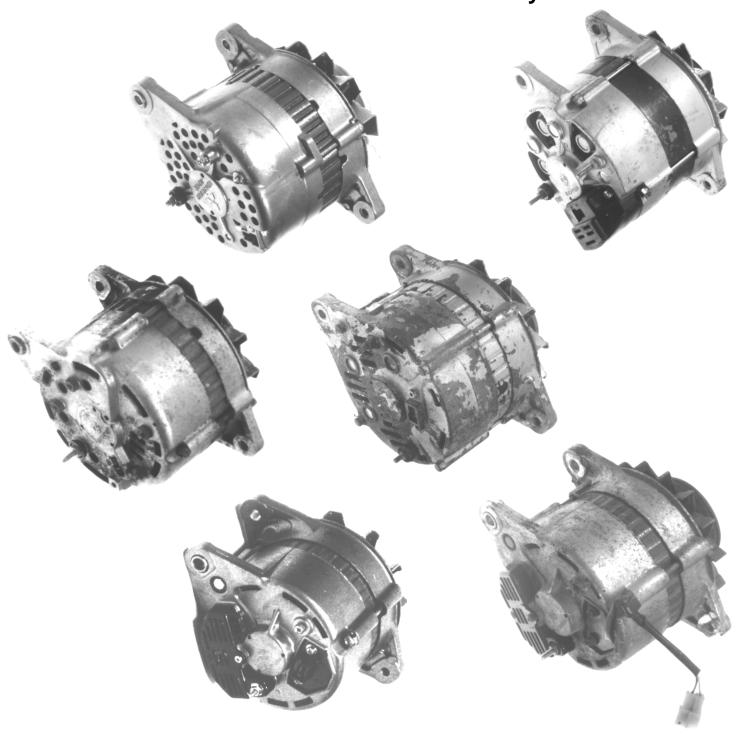
#### These units are interchangeable

Although the unit you purchased may not look exactly like the one removed from the vehicle, it will install and operate with no modifications necessary.
