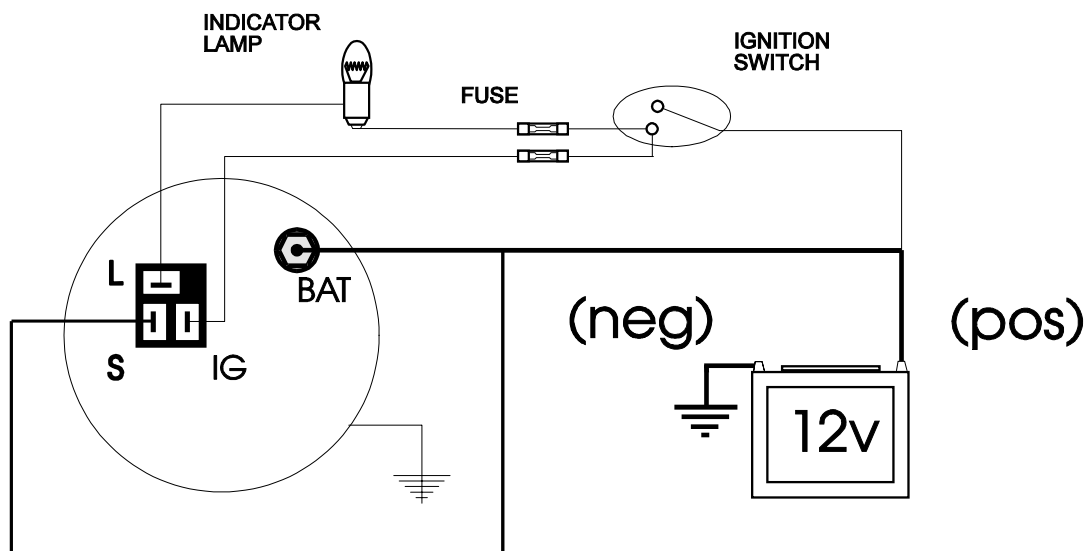
1. The “BAT” terminal must have battery voltage. This voltage is supplied directly from the battery and will be present whether the ignition switch is in the “ON” or “OFF” position. Failure to have voltage at this terminal will cause:

- No charge, indicator lamp on.
 - Extremely high voltage at “BAT” terminal.
 - Possible damage to alternator diodes.
2. In addition, the wire leading to terminal “L” should have voltage when the ignition switch is in the on position. Failure to have voltage at this terminal will cause:

- Erratic charging
3. The IG terminal must have battery voltage when the ignition switch is in the on position. Failure to have voltage at this terminal will cause:

- No charge, indicator lamp on
4. The “S” terminal must have battery voltage at all times. Failure to supply full battery voltage to terminal may cause:

- Overcharge.
 - No Charge, depending on regulator design.
5. This series of Toyota vehicles is especially prone to poor connections near the battery. Check the small plug in connectors (fusible links) near the battery for signs of corrosion.
