CARDONE ProTech

Excessive Rotation of Steering Causes Air Bag Coil Damage

Application All vehicles equipped with steering column air bags.

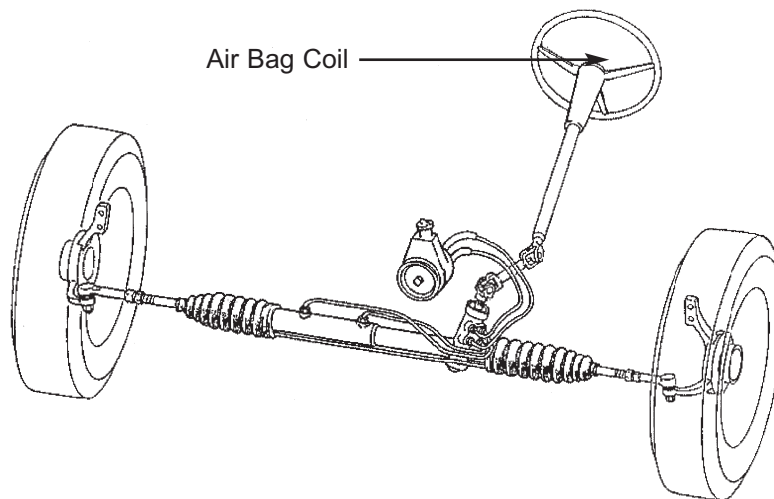
Problem Steering column air bag inoperative after steering gear replacement.

Cause Excessive steering wheel rotation during installation of steering gear, resulting in a broken air bag coil.

Solution The steering wheel **must** be held in the center position prior to removal of intermediate steering shaft (use appropriate tool). This will prevent excessive rotation of the steering column and failure of the air bag coil.
