CARDONE ProTech

Don't Get Power Cylinder or Control Valve Hoses Crossed

Application All linkage-type Power Steering Systems

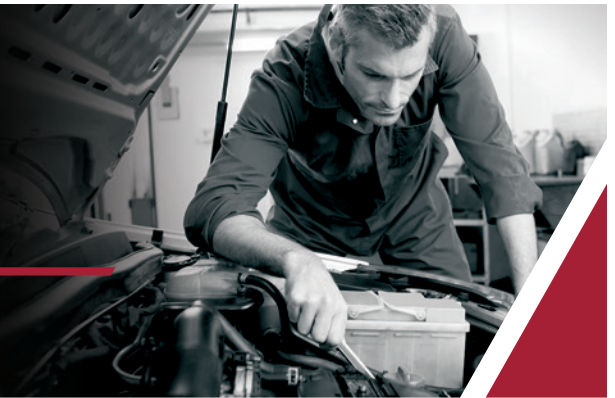
Problem After replacing the power steering unit, the vehicle steers violently from side to side by itself.

Solution When installing a control valve or power cylinder, be extremely careful not to cross the pressure lines to the cylinder. Failure to do so can lead to a malfunction and could result in bodily injury and VOID WARRANTY.

Caution When replacing any part in the power steering system, ALWAYS FLUSH THE SYSTEM USING APPROVED POWER STEERING FLUID AND REPLACE HOSES! New parts can become contaminated with residues from existing components possibly causing malfunctions.
