CARDONE™ ProTech®

Solving Brake Lockup on Honda/Acura Boosters

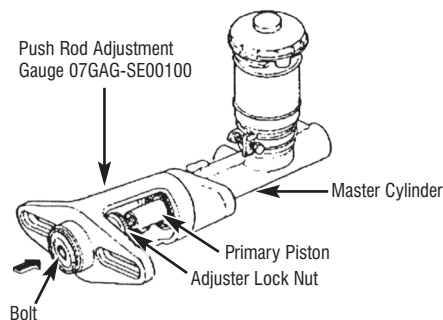
Figure 1: Adjusting Master Cylinder Push Rod

Proper adjustment can not be made until vacuum is applied to the booster. To properly adjust the master cylinder push rod, a special gauge is required. Please refer to vehicle service manual for specific procedure and required tool (tool 07JAG-SD40100). See figures 1 and 2 below.

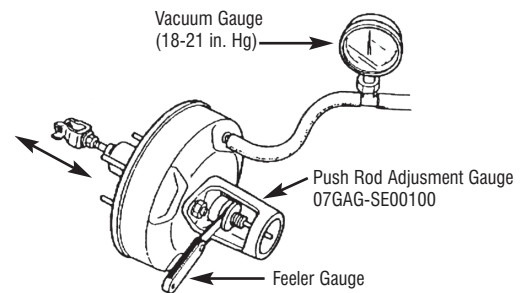
Figure 2: Checking Brake Booster Push Rod Clearance

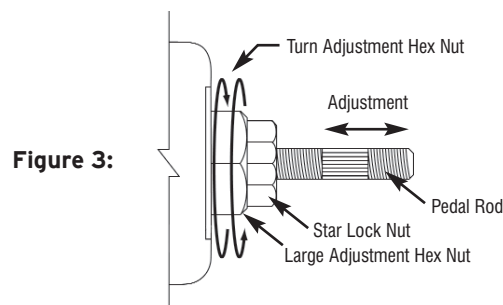
Figure 3:

Turn adjustment nut clockwise to move rod in, counter-clockwise to move rod out.

To adjust rod position, loosen the star lock nut at the base of the booster. Then turn larger hex nut to adjust the push rod-to-piston clearance as needed (see figure 3 below). Tighten star lock nut and install unit as per installation instructions.
