CARDONE ProTech

Relocating Power Steering Hose May Eliminate Vibration

Application: All power steering equipped vehicles.

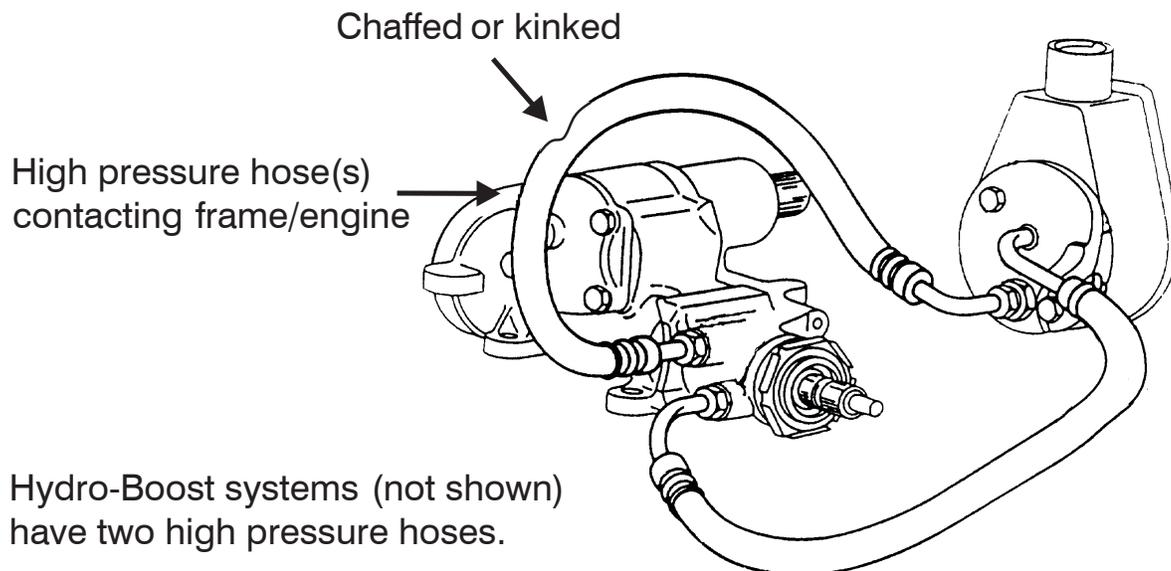
Problem: Power steering noise.

Cause: Power steering pressure hoses vibrate under high pressure. Hoses may be contacting the body, frame or engine oil pan causing noisy operation.

Solution: Relocate the power steering hoses. Check for missing hold down clamps or hardware. Replace damaged hoses as necessary.

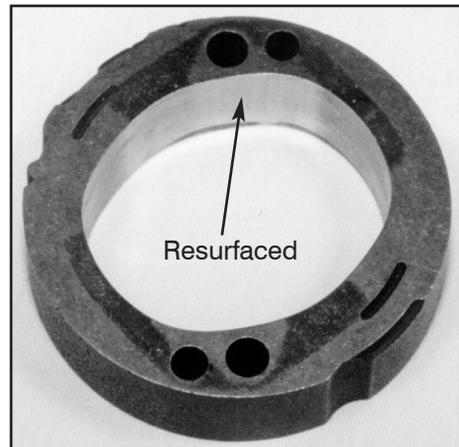
Cam Rings - In order to prevent low flow, noise, or no pressure, CARDONE resurfaces the cam ring to give it the original, consistent surface. By running your finger around the inside of the cam ring, you will be able to feel the smooth inner surface. Every unit is tested for proper flow and pressure to make sure it meets all OEM specifications. This process ensures a high quality unit that won't come back.
