TECHNICAL SERVICE BULLETIN

COOLING SYSTEM

AUTOMOTIVE SEALANT USE DURING WATER PUMP REPLACEMENT

BULLETIN TSB_057_US

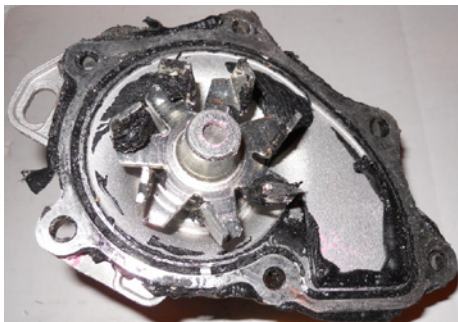
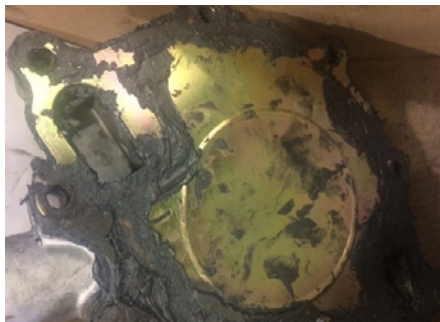
Both pumps were supplied with a cellulose / rubber binder gasket. These gaskets do not require the use of any sealants. However if the mating surface is damaged, a small skim coat of sealant is allowable with these types of gaskets.

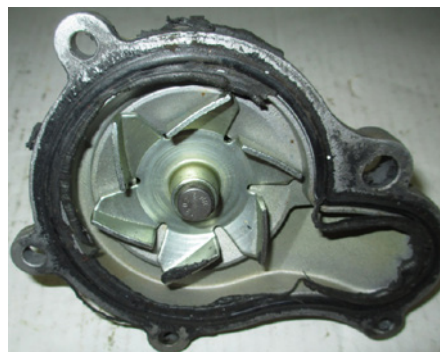
Both pumps were supplied with a rubber / O-ring style gasket. These types of gaskets do not require the use of any sealants.

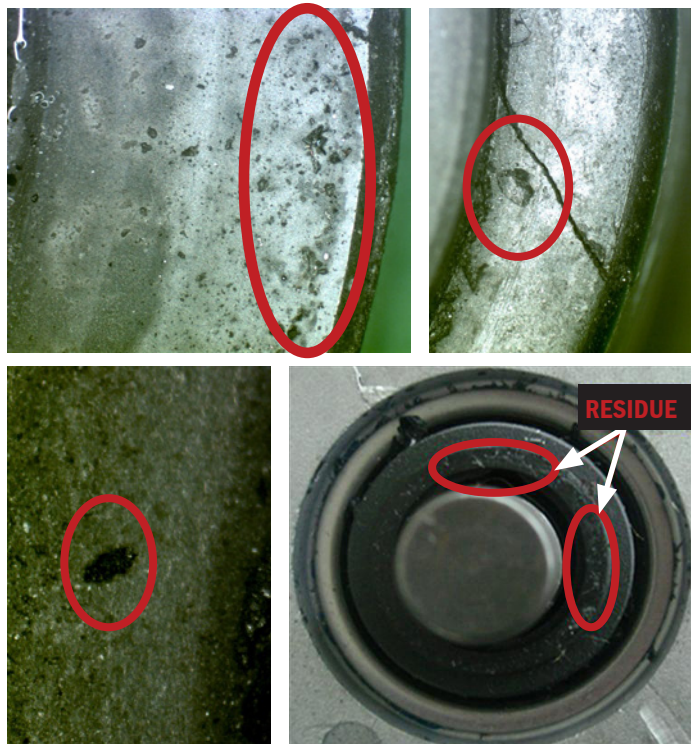
To the left are examples of Dynamic and Static seal contamination/filming caused by over use of sealants.

When sealant particulates/residue get trapped between the Dynamic and Static seal faces, a separation of the two surfaces results, leading to a seal leak.
