LUBRICATION ISSUES

THE PROBLEM SOLVER®

Inadequate lubrication due to dislodged anti-drainback valve

MOOG® Patented Thrust Washer Design with integral anti-drainback valve

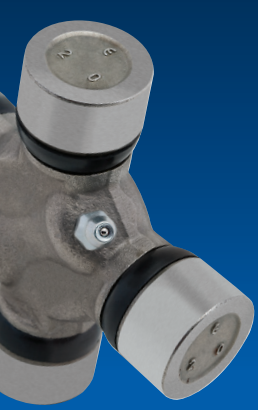
A thrust washer helps absorb axial loads and prevents galling. The MOOG® patented thrust washer design for medium duty, heavy duty, off-highway and larger PTO joints incorporates an exclusive anti-drainback feature.

The MOOG internal anti-drainback valve is integrated into the thrust washer to control lubrication flow and prevent dry start-up. Because it is integrated as a one-piece design into the thrust washer, it cannot separate and allow grease to drain back or block the flow of lubrication.

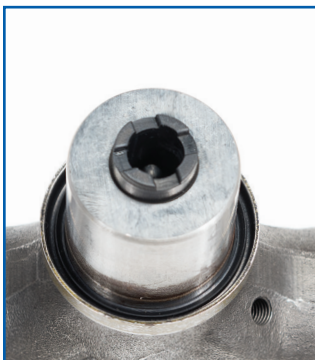
An anti-drainback valve prevents dry start-up, which causes excessive wear. Other suppliers may leave the anti-drainback valve out to cut costs or provide it as a separate component in the trunnion, where it may dislodge. If an anti-drainback valve were to become dislodged, it will fail to function properly. The subsequent draining and loss of lubricant in the bearing cup may cause excessive wear at start-up and slow speeds.

SUPPLIER 1: NON-INTEGRATED ANTI-DRAINBACK VALVE; NO THRUST WASHER

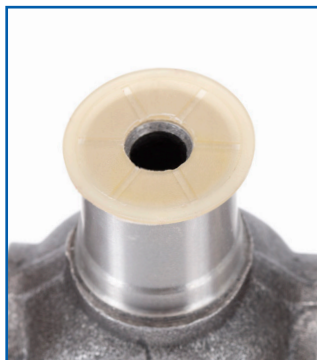
SUPPLIER 2: THRUST WASHER INCLUDED, BUT NO ANTI-DRAINBACK VALVE

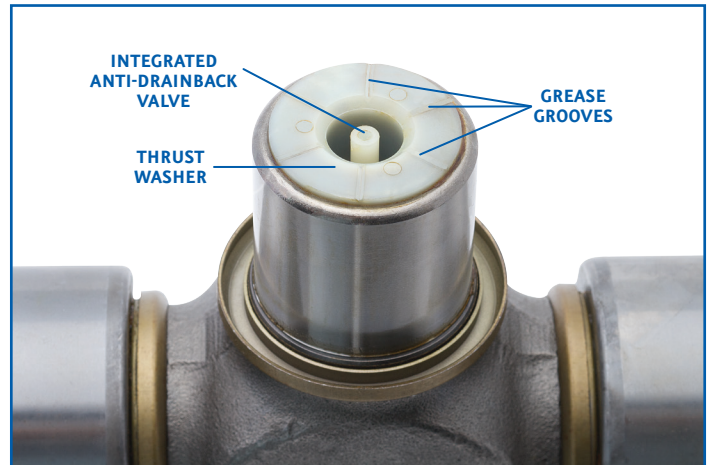
In addition, the MOOG reinforced nylon thrust washer material stands up to extreme loads, eliminates metal-to-metal contact, and lowers the operating temperature by reducing friction. Galling on trunnion ends is also eliminated.

MOOG® PATENTED THRUST WASHER DESIGN
