THE PROBLEM SOLVER®

PROBLEM:

Lower Ball Joint Failure

**MOOG® Problem Solver®
K7467 Lower Ball Joint**

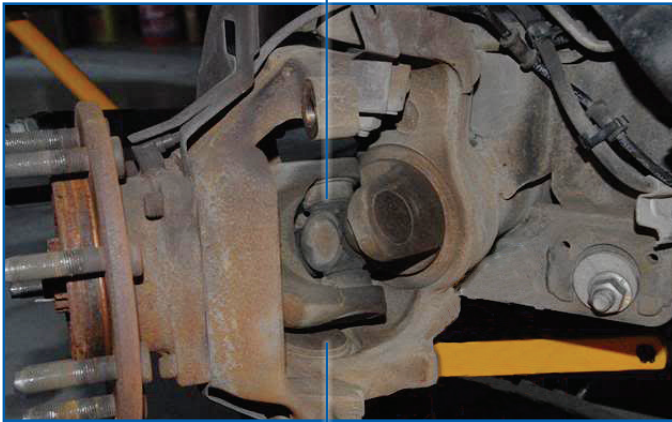
OE and other suppliers' designs can lead to early failure in vehicles that are subject to adverse road conditions or severe duty use.

- Plastic bearing is subject to excessive wear.
- No provision for preload can lead to excessive deflection and degradation of socket torque as the bearing wears.
- OE ball joint is non-greaseable, and the tight installation clearance makes servicing other suppliers' ball joints difficult.

OUTER U-JOINT

NOTE LIMITED CLEARANCE

Note:
In order to remove and install the lower ball joint, the knuckle must be removed. We recommend that you replace the outer universal joints at this time, as they are easily accessible during this procedure.

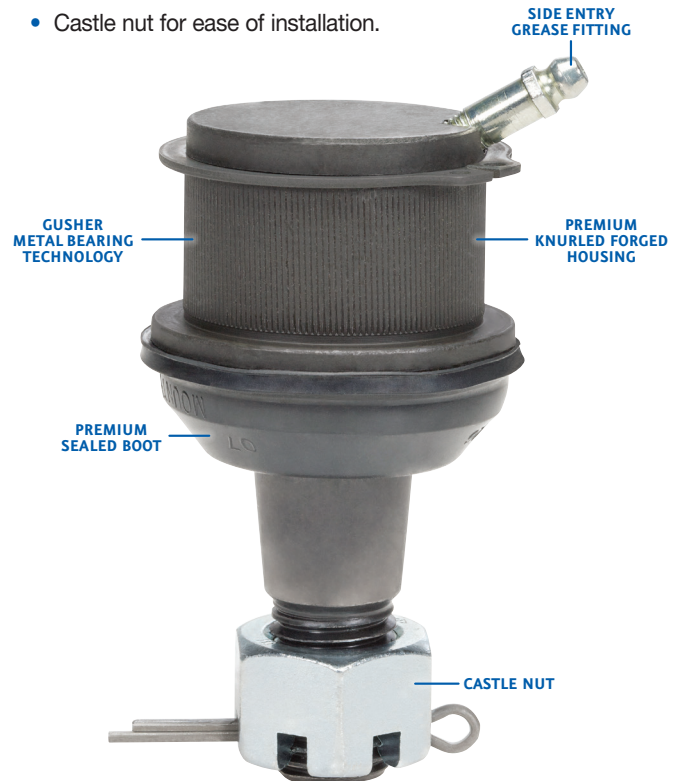
The MOOG® Problem Solver® K7467 ball joint features many improvements over the OE and other suppliers' ball joints.

- Exclusive powdered-metal "gusher" bearing improves wear resistance and durability.
- Belleville washer ensures proper preload and consistent socket torque for the life of the part.
- Premium knurled housing ensures strength and a secure installation.
- Premium black polychloroprene boot lasts longer than blue neoprene boots.
- Side-entry style grease fitting allows easy service of ball joint while on vehicle.
- Castle nut for ease of installation.
