MOOG® EXCLUSIVE BEARING DESIGN

THE PROBLEM SOLVER®

Premature Failure/Excessive Play/Joint Separation

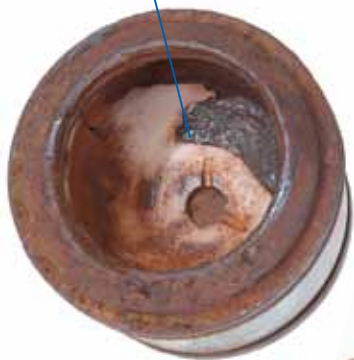
- Non-serviceable socket design cannot flush contaminants from the assembly, causing corrosion and wear.
- Boot deterioration/failure can lead to lubrication loss. The bearing quickly wears, resulting in excessive deflection, imprecise steering/alignment and possible assembly separation.
- Plastic bearings do not uniformly transmit force into the wall of the housing and cover plate, causing deformation and wear. This affects steering stability and results in shorter service life.

NOTE WORN AWAY PLASTIC SOCKET

- MOOG's hardened powdered-metal bearing design allows grease to flow through the bearing surface and onto the stud for reduced friction and long life.
- Porous material allows continuous lubrication to flush away contaminants from the bearing and stud surface, resulting in less wear and increased performance.
- Unique bearing design evenly transfers vehicle load forces and prevents bearing deformation, resulting in a robust and durable part.
- Hardened bearing construction provides strength and stability while restoring like-new steering.

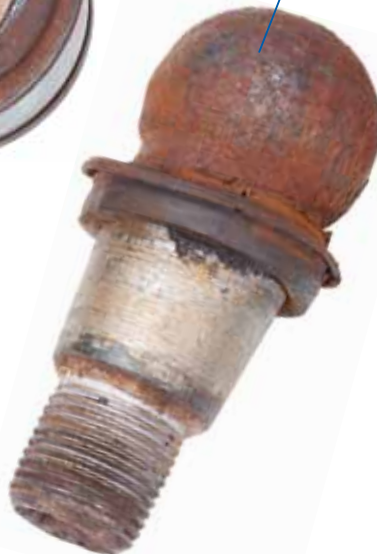
BALL STUD SEVERELY CORRODED
