# TECHNICAL SERVICE BULLETIN

## SYNCHRONOUS BELT DRIVE SYSTEM

### REAR CAM ALIGNMENT

BULLETIN TSB\_044\_US

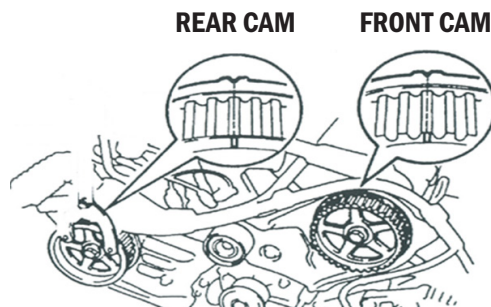
The most common cause found with immediate illumination of the MIL associated to cam sensor codes has been misalignment between the rear cam gear and timing belt. Illumination of the MIL will occur with the cam being one tooth advanced or retarded.

**REAR CAM ALIGNMENT WITH MIRROR FOR VERIFICATION HIGHLY RECOMMENDED**
