Technical Service Bulletin

AUTOMOTIVE <> PASSENGER CAR SYNCHRONOUS BELT DRIVE SYSTEM

BULLETIN PA008-11

REAR CAM ALIGNMENT

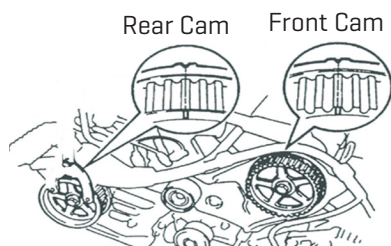
The most common cause found with immediate illumination of the MIL associated to cam sensor codes has been misalignment between the rear cam gear and timing belt. Illumination of the MIL will occur with the cam being one tooth advanced or retarded.
