# PROBLEM *Solver*<sup>™</sup> BULLETIN

## Tie Rod End Failures

2001-2004  
General Motors  
1500/2500/3500 Trucks

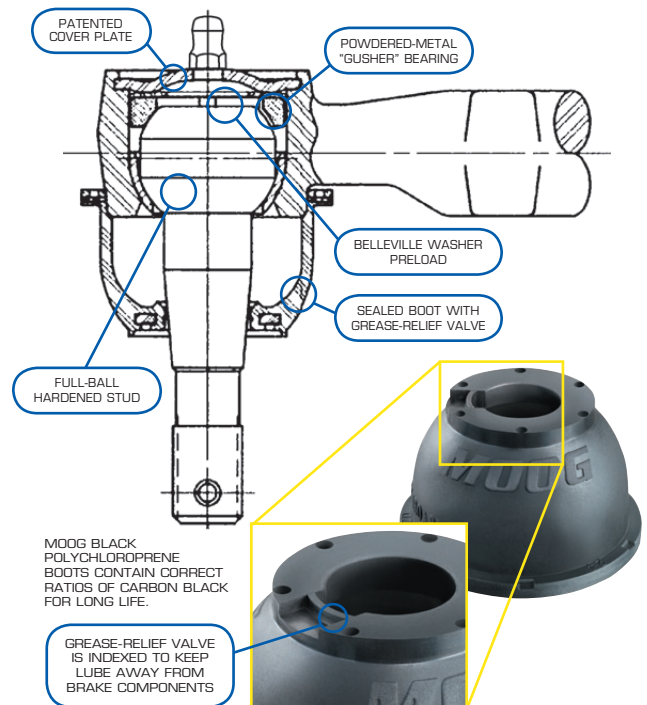
#### MOOG® ES3609

- The MOOG tie rod, featuring a greaseable design, uses a premium polychloroprene boot with a special grease-relief valve designed to resist intrusion and flush contamination out of the socket, preventing corrosion and premature wear.
- Hardened powdered-metal “gusher” bearings allow lubrication to penetrate the bearing surface, providing the most durable bearing available for longer service life.
- A full-ball stud maintains ball-to-bearing contact for greater load capacity.
