WIRING REQUIREMENTS FOR "CS" SERIES ALTERNATORS:

LOW OUTPUT

1987-1988 PONTIAC 6000 & GRAND PRIX 2.8L V6

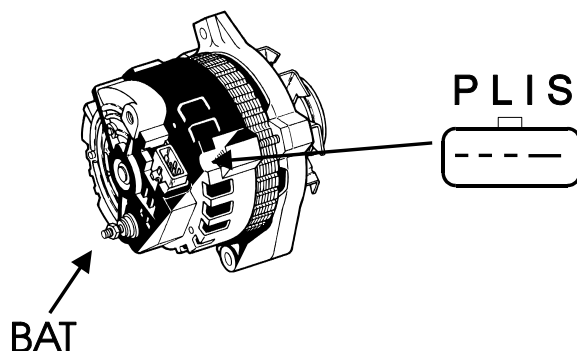
GM uses several wiring configurations for this alternator. This diagram explains the purpose of each regulator terminal. Note that terminal I and L activate the alternator. The alternator will not charge without voltage present at I, L, or both I and L.

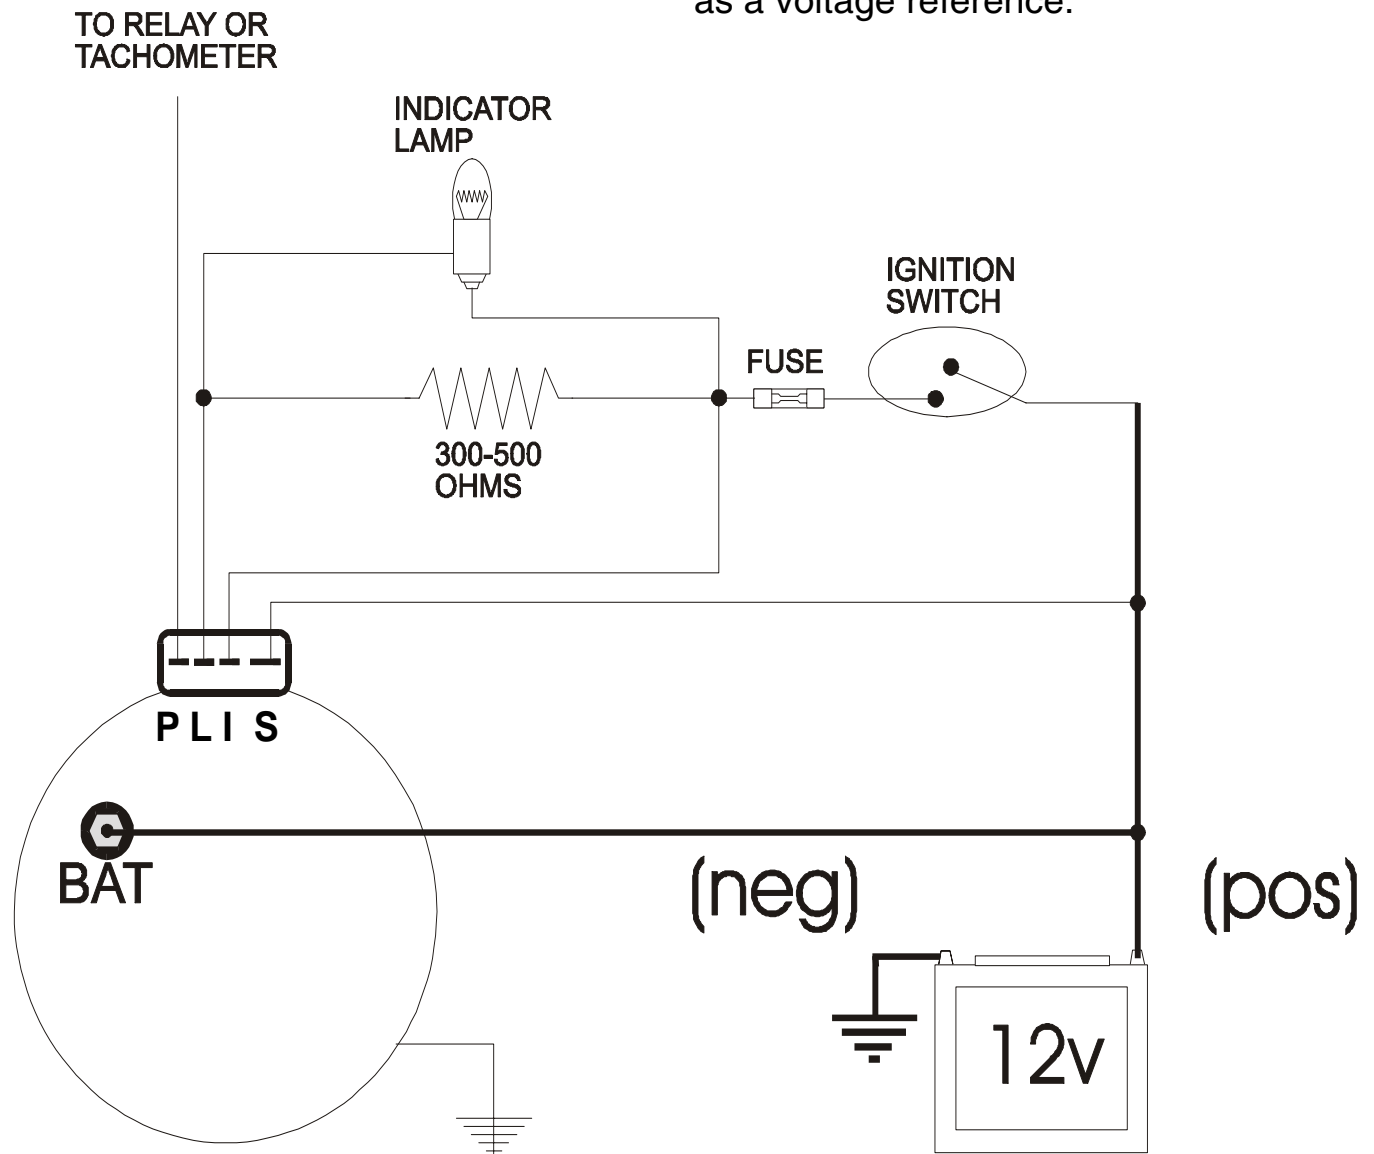
LOW ALTERNATOR OUTPUT AND ALTERNATOR IS OPERATING CORRECTLY

THIS CONDITION IS CAUSED BY THE ALTERNATOR BRACKET HARDWARE BEING PHOSPHATE COATED (BLACK STUDS & NUTS) WHICH MAKES AN INSUFFICIENT GROUND PATH

1. LOCATE AFFECTED HARDWARE (SEE PICTURE)
2. REMOVE ONE (1) NUT AT A TIME (REPAIR ONE AT A TIME SO YOU DO NOT MOVE THE POSITION OF THE BRACKET)
3. CLEAN STUD WITH A WIRE BRUSH TO BARE METAL
4. REPLACE NUT WITH GM PART NUMBER #11502812 CADMIUM COATED NUT THAT IS MORE ELECTRICALLY CONDUCTIVE THAN THE ORIGINAL
