Bolt-on Air Pump Pulleys Can Be Installed Wrong

Application All air pumps (smog pumps) with bolt-on pulleys.

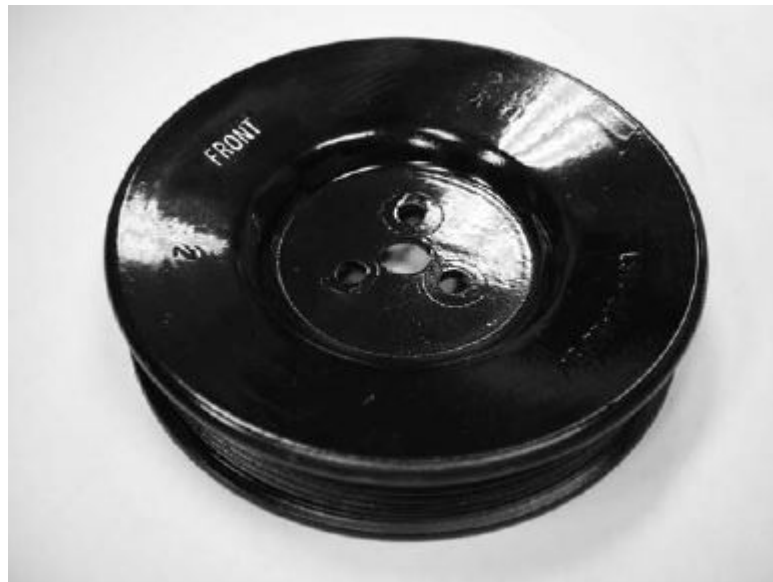
Problem The original pulley rubs on the housing of the replacement unit, or the belt does not track correctly.

Cause Pulley is mounted wrong-side out (the pulley will mount on the pump either way).

Solution Original Equipment pulleys usually are marked FRONT or THIS SIDE OUT. Another way to determine the correct side is that the shallow side of the pulley must face towards the pump and the deep-dished side faces out (away from the pump). When reusing the original pulley, look for hub marks on the inside surface or washer marks on the outside surface. Aftermarket pulleys may not be marked. In this case the deep-dish side usually faces outward as noted above.
