# CARDONE ProTech

## Common Causes of Damaged Rack and Pinion Threads

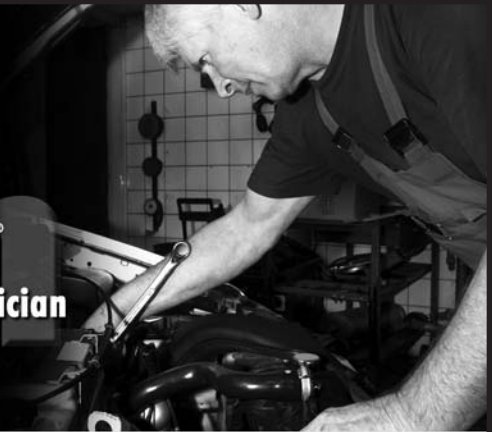
Damage to threads/housing during installation of the power steering hoses.

Cross-threading or over-tightening of the power steering hose fittings.

Clean and inspect the power steering hose fittings.

- **DO NOT** use power steering hoses that are cracked, chaffed, soft or have damaged fittings.
- Install new "O" rings if applicable. Lubricate with new fluid recommended for your vehicle. **CAUTION: DO NOT USE THREAD SEALING TAPE OF ANY KIND ON THE FITTINGS!**
- Finger-tighten all power steering hose fittings prior to tightening to final torque.
- Torque power steering hose fittings to manufacturer's specifications for your vehicle.
- Flush system using fluid approved for your vehicle according to instructions provided with the replacement rack & pinion and service manual.
