CARDONE ProTech

Why Did the Water Pump Shaft Break?

Broken water pump housing or shaft fracture.

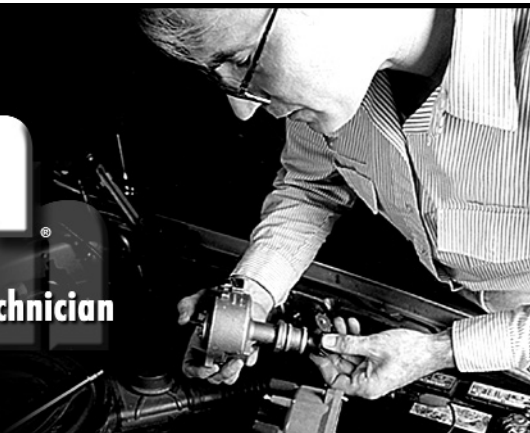
Excessive vibration and unbalanced load due to:

- Improperly torqued mounting bolts
- Bent or distorted pulley(s)
- Defective fan clutch (if applicable)
- Improperly tightened belts

Always replace damaged fans,
never try to straighten

- Torque mounting bolts and fan assembly bolts evenly to proper manufacturer's specifications.
- Check fan clutch for binding, looseness or leakage - replace if necessary.
- DO NOT strike shaft.
- Check fan for damage.
- Make sure pump turns freely by hand.
- Tighten fan belts to factory recommended tension - replace if worn or frayed.
- Check motor mounts - loose or broken mounts will allow fan to hit radiator shroud.
