# CARDONE™ ProTech®

## 81-158PB Replacement Pulse Board Park Problem

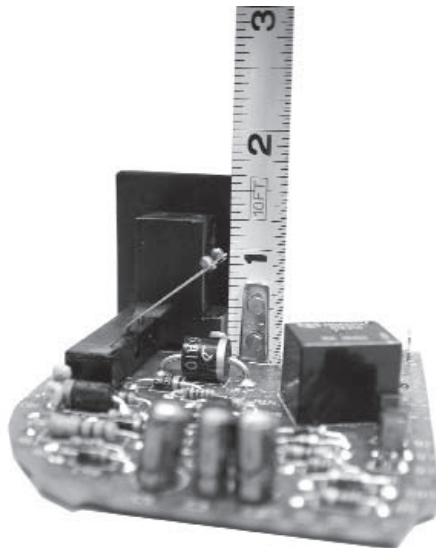
Check position of contact arms before installation. Contacts should be approximately 1 inch (25 mm) above circuit board (see picture). Correct contact position ensures proper Wiper Motor parking function.

Contact arms on Pulse Board may not be contacting Wiper Motor. Packing material or movement during shipping may have bent contacts.
