TO CHECK FOR PROPER STARTER VOLTAGE

**1999-2000 Cadillac Escalade
1995-2000 Chevrolet and GMC S/T models
1996-2000 Chevrolet and GMC C/K, M/L, G, P models
1996-2000 Oldsmobile Bravada**

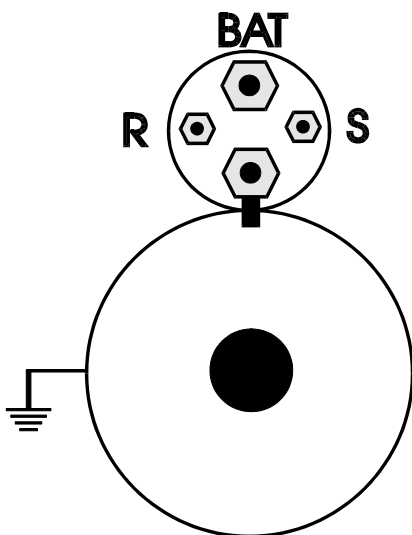
1. Install starter and fasten all electrical connections securely.
2. **Connect** a voltmeter to the starter in this manner. Black lead to starter case; red lead to "S" terminal. Attempt to crank engine.

NO CRANK - VOLTAGE LESS THAN 12 VOLTS:

If the engine does not crank and voltage is less than 12.0 volts check for defective neutral safety switch, bad ignition switch, weak battery, or poor ground.

NO CRANK – VOLTAGE MORE THAN 12 VOLTS:

If the engine does not crank and voltage is MORE than 12.0 volts. Proceed to step 3.

3. Move red wire of voltmeter to starter BAT post.
4. Turn the ignition key to the crank position.
5. Observe the voltmeter:

Check for weak battery, loose or corroded cables

CRANKS - VOLTAGE LESS THAN 9 VOLTS:

Cranking at less than 9 volts will damage the starter. This condition must be corrected to prevent a repeat failure. Check for weak battery, loose or corroded cables
