1995-1998 FORD CONTOUR 1995-1998 MERCURY MYSTIQUE 2.0L and 2.5L

Ford Motor Co. Warning

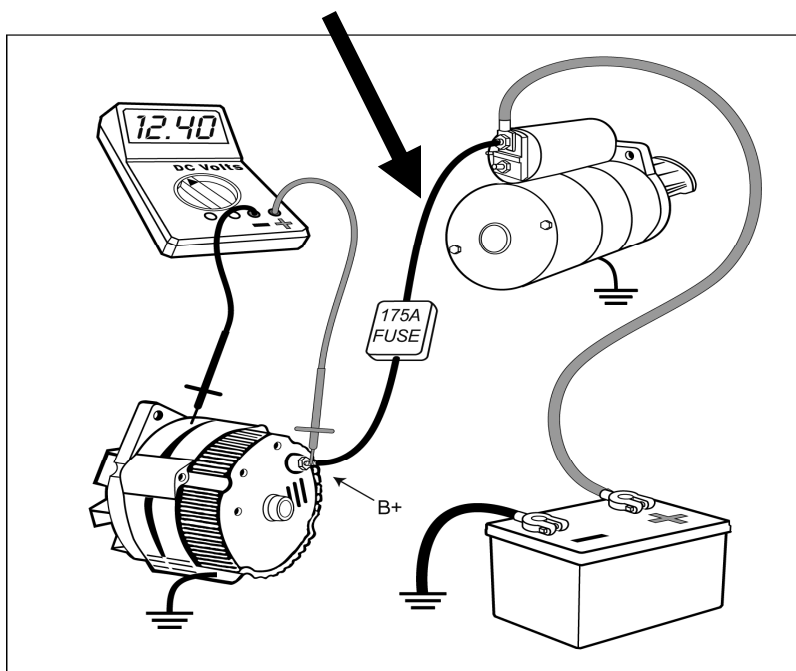
The alternator B+ cable runs from the B+ stud at the alternator to a 175 Amp “mega fuse” then to the starter solenoid. This is the cable that will need to be replaced if your car is experiencing this problem. Ford Motor Co. part number is F5RZ-14300-FA. If the alternator B+ stud is damaged, you must also replace the alternator.

The charging system indicator may be on or the battery may be dead. This situation may be due to a poor electrical connection on the Alternator output wire. Inspect or replace as follows.
